# **Suspect/Counterfeit Items Awareness Training**

**U.S. Department of Energy  
Health, Safety and Security  
Office of Corporate Safety Analysis**

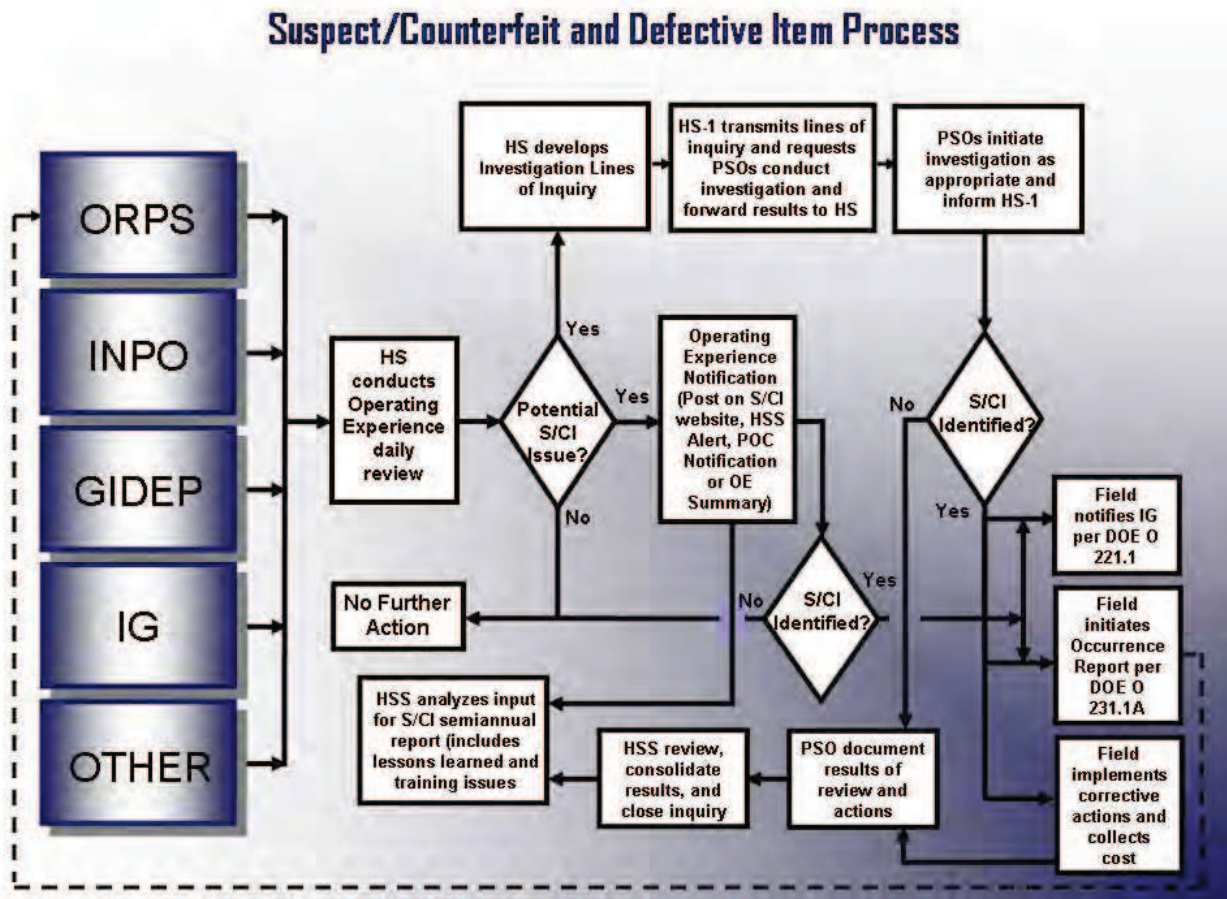
The S/CI process flow chart is included in the *Office of the Environment, Safety and Health Process Guide for the Identification and Disposition of Suspect/Counterfeit Items at Department of Energy Facilities*. The detailed Process Guide can be found on the Office of Corporate Safety Analysis Suspect/Counterfeit-Defective Items website at <http://www.hss.energy.gov/csa/csp/sci/> that includes S/CI-related information and links to other related websites.

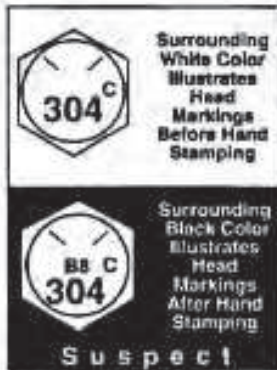
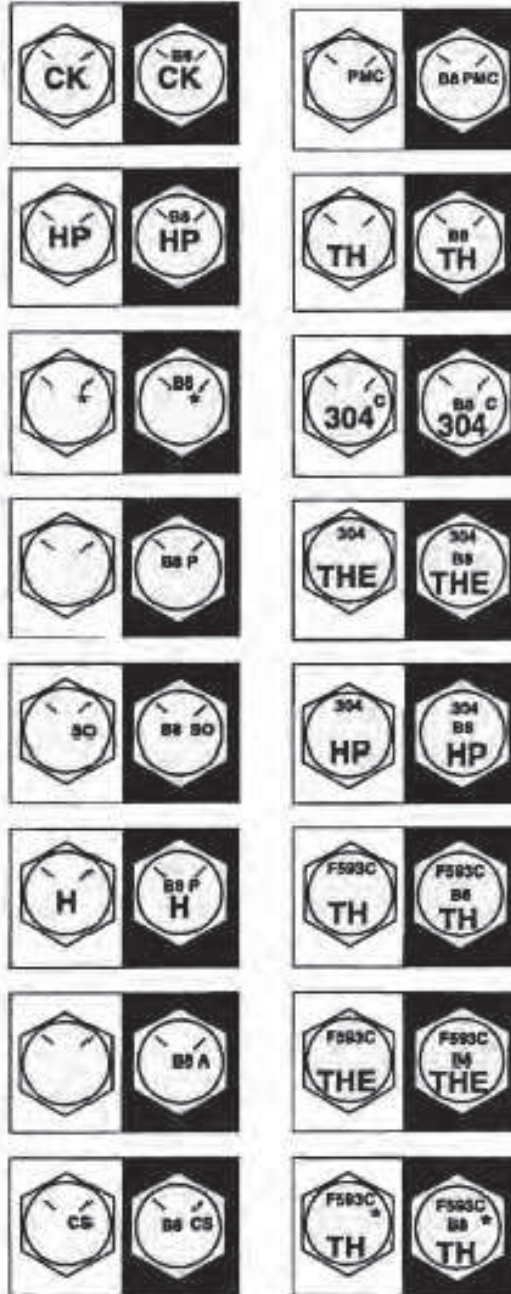
If any of these fasteners are located, contact your facility B/C Point of Contact (POC) for instructions. The POC list is on the Hanford Intranet at: <http://docs.ri.gov/han.info/hianect/hianect.doc>. Scroll to the end of the document for the list.

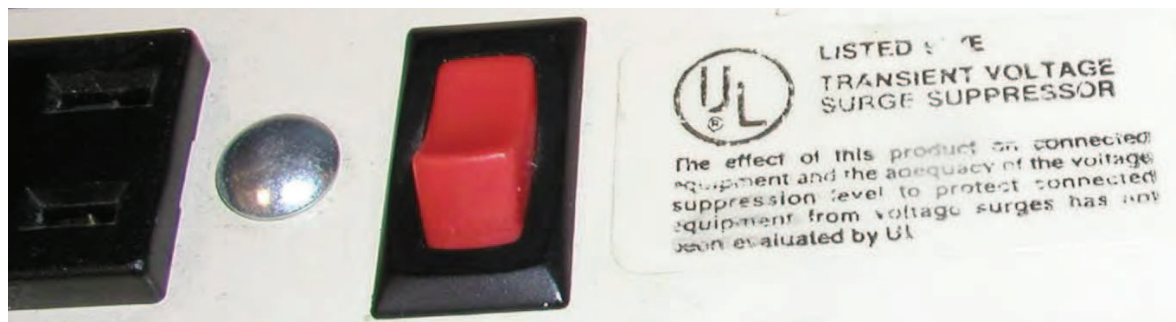
### Found at DOE Headquarters in Germantown, MD

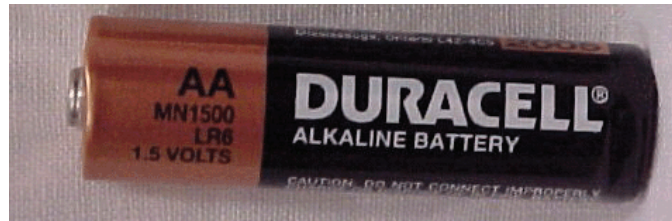
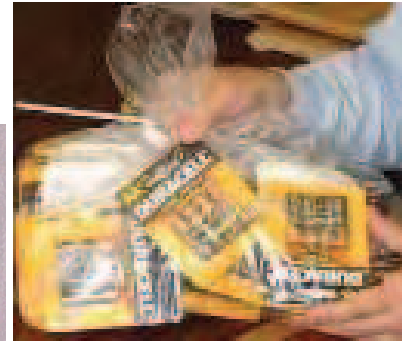
Authentic **DURACELL®** battery on the left. Counterfeit **DURACELL®** batteries on the right spell the name the same as the authentic batteries.

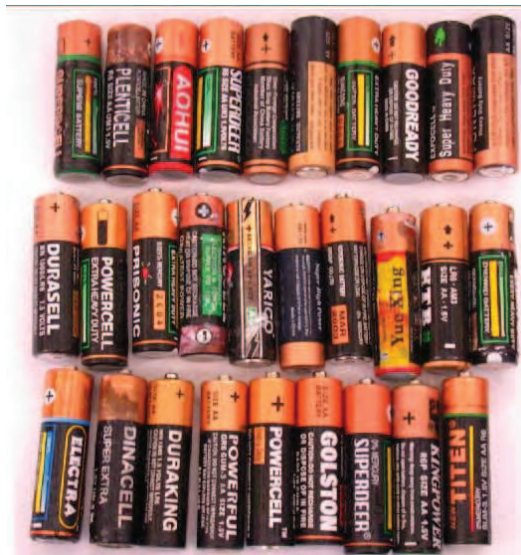
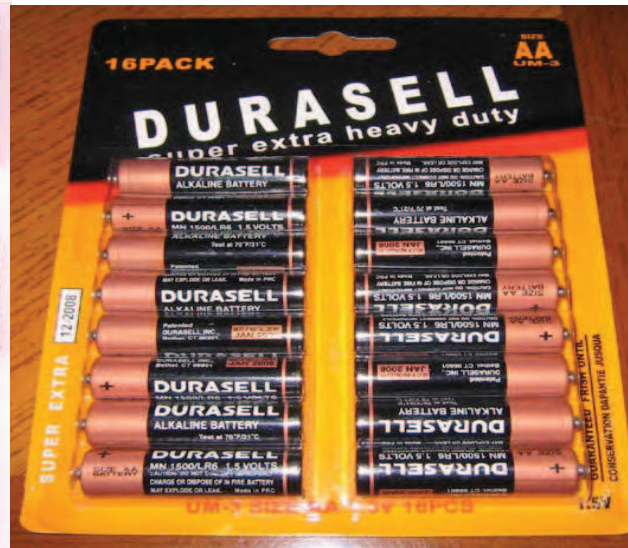
On the left - Examples of DURACELL clones simulating trademarked DURACELL colors (note several are leaking). Some have flimsy casings that crush easily under pressure by hand. The counterfeit batteries on the right the batteries are spelled differently but constitute trademark infringement (black and gold copper top).

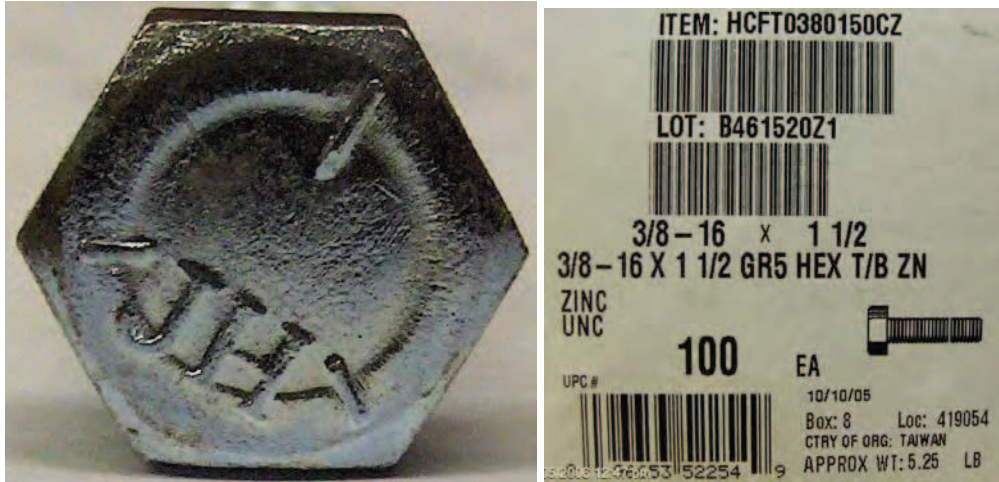
This Jinn Her “JH” Grade 5 Hex Bolt from the West Valley Demonstration Project (WVDP) was received in December 2005. Jinn Her “J” headmarks on grade 5 and grade 8 high-carbon steel fasteners are deemed counterfeit. However, Jinn Her has the “JH” insignia currently registered in the U.S. through the U.S. Patent and Trademark Office. The fasteners were ordered as domestic, yet the supplier provided the foreign-made Jinn Her fasteners from Taiwan. The fasteners were tested and found to meet WVDP specifications. WVDP has chosen to use these fasteners. This insignia (headmark) appears on the FQA Register of Active Fastener Insignias at <http://www.uspto.gov/web/offices/tac/fqa/fqa.htm>.

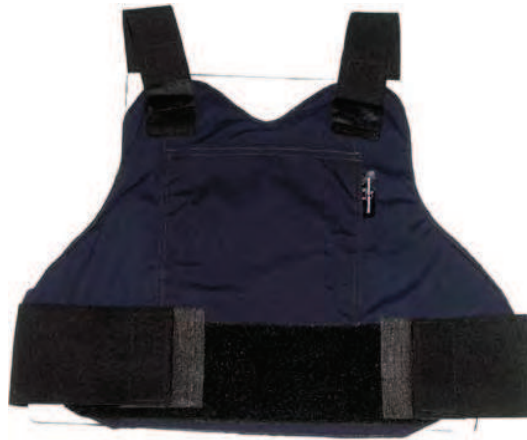
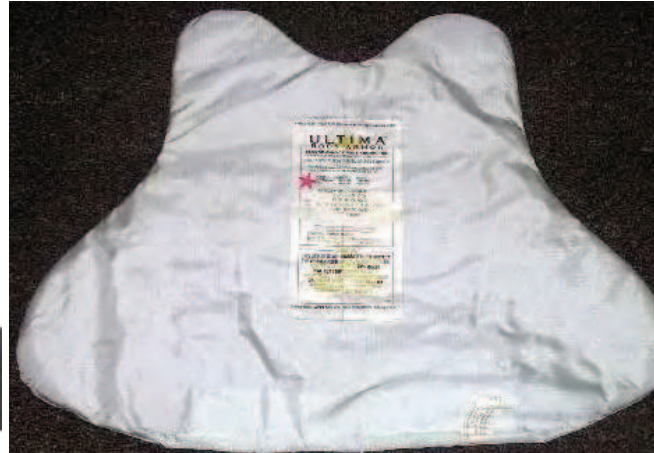
Bulletproof vests manufactured by Second Chance Body Armor, Inc. ("Second Chance"), which contains Zylon<sup>®</sup>, a fiber manufactured and sold by Toyobo Co., Ltd. and Toyobo America, Inc., and sold by Second Chance and its distributors under the trade names ULTIMA, ULTIMAX, and TRIFLEX. These vests fail to meet the performance characteristics for which they were warranted, degrading at a quicker than expected rate from light, humidity, and temperature. Allegedly, the defective condition of the vests was withheld from the marketplace. Upwards of 20% of the ammunition fired at these vests penetrated the fabric.

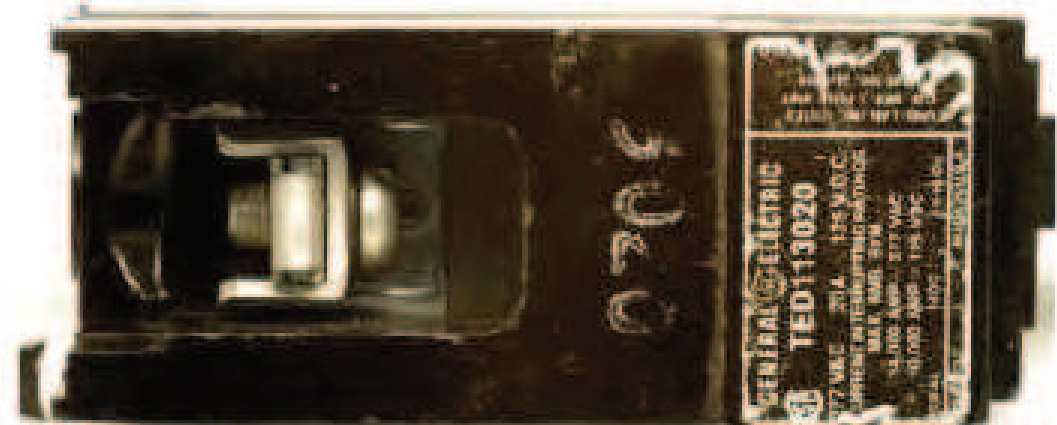
Label marked General Electric and "GE"  
Manufacturer stopped marking with both indicators over 20 years ago  
Label very worn

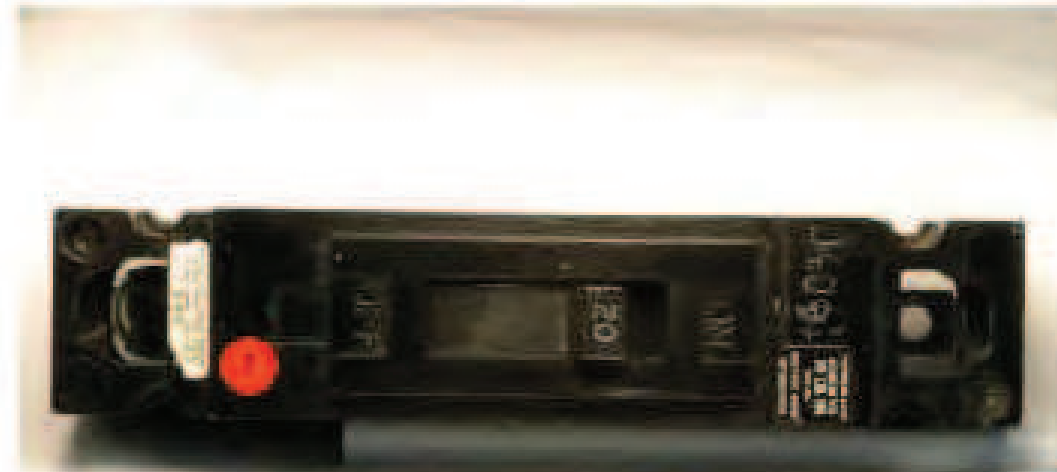
## GE Molded Case Circuit Breaker

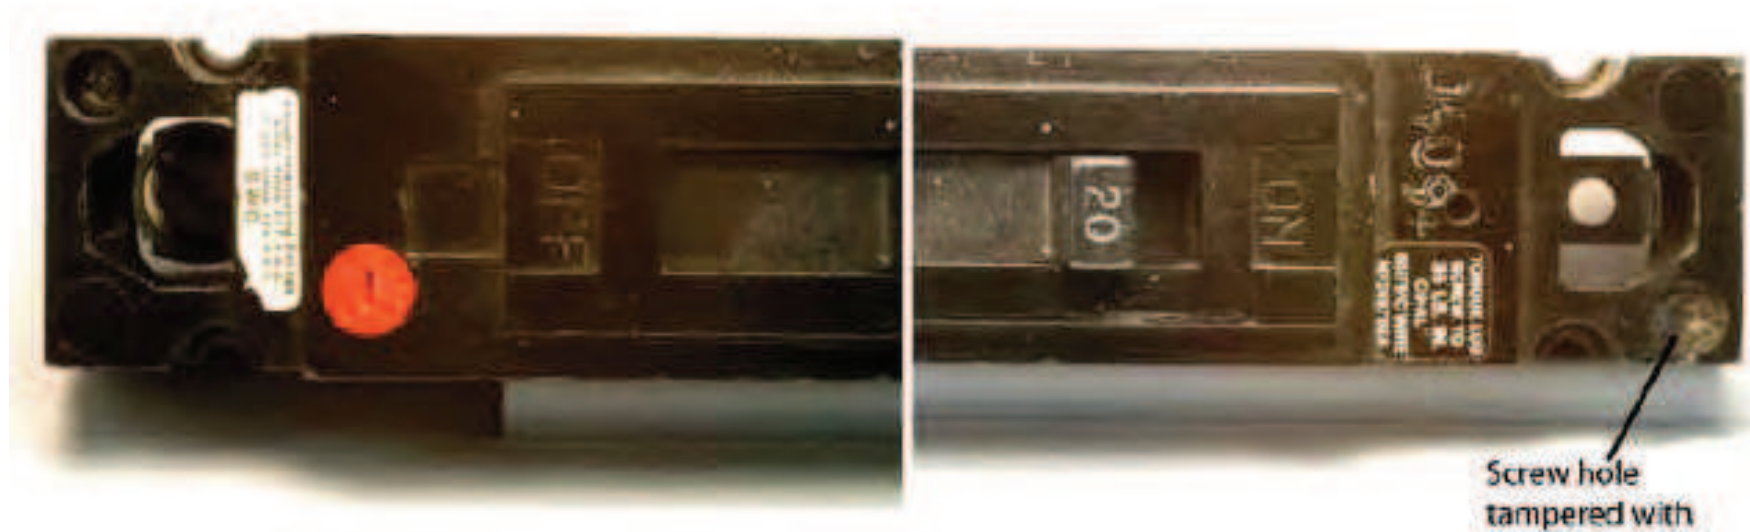
Sold as new by supplier  
Indications of being used or refurbished  
Label worn and torn

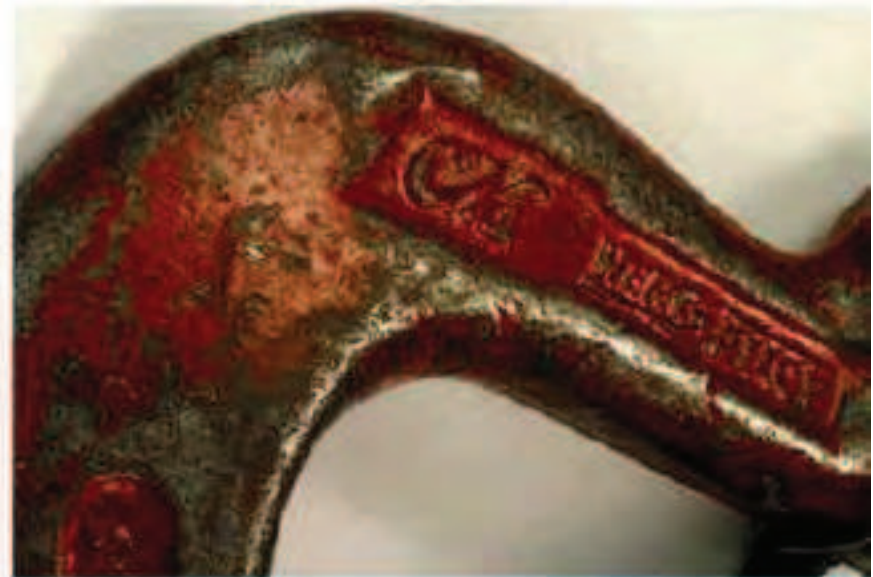
Red color is the Crosby Group, Inc. trademark-patented color  
Represented as being new in condition shown above  
Appearance very worn

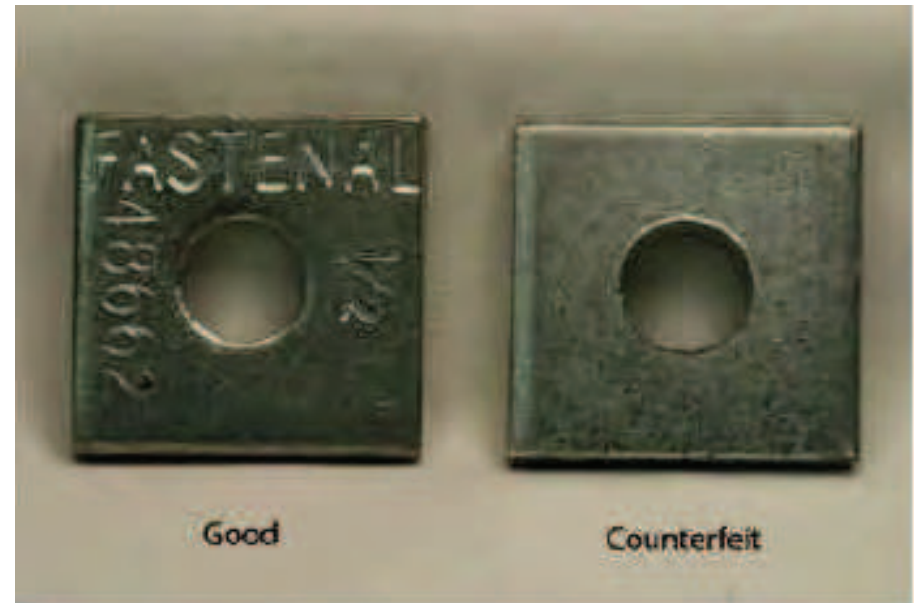
### Stainless Steel "T" Weldolet Counterfeit

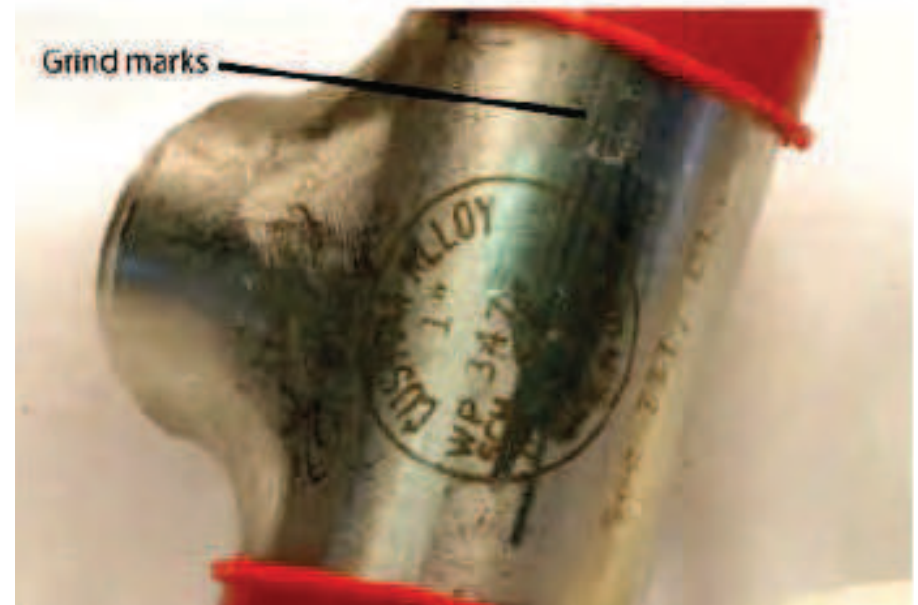
## Comparisons of Square D Breakers
